## COHOES RESERVOIR NO. 3

INVENTORY NO. N.Y. 1314

### PHASE I INSPECTION REPORT NATIONAL DAM SAFETY PROGRAM

JUNE, 1981

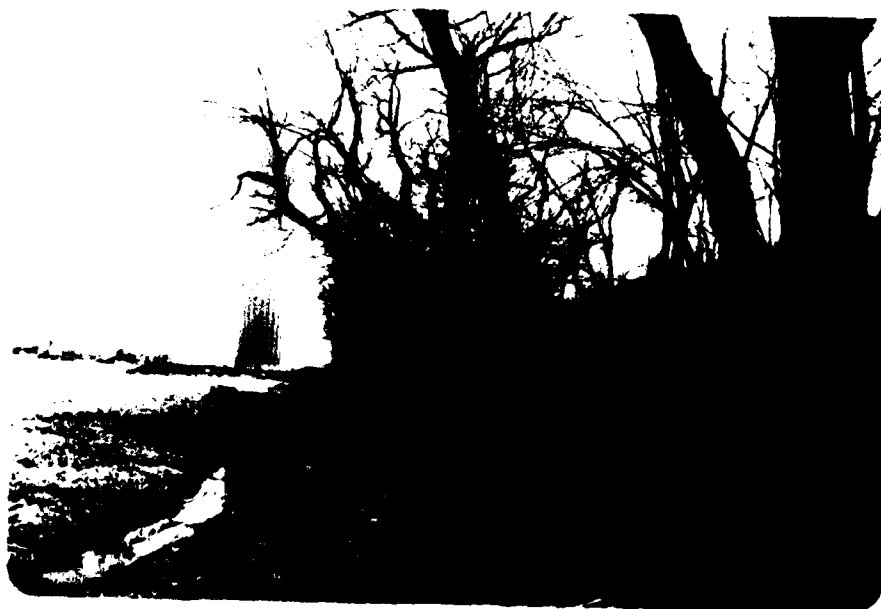
Drainage Ditch Running Near Toe of  
Northern Slope; Note Trees on Slope

- (1) Estimate - (V:H) 1:2
- (2) Undesirable Growth or Debris SUBSTANTIAL AMOUNT OF TREES & BRUSH
- (3) Sloughing, Subsidence or Depressions NONE
- (4) Surface Cracks or Movement at Toe NONE
- (5) Seepage NONE
- (6) External Drainage System (Ditches, Trenches; Blanket) DITCH RUNS ALONG TOE FOR 50' & THEN ABOUT 20' OUT FROM TOE - ABOUT 100' FROM END IT TAKES BEND INTO EMBANKMENT & DISAPPEARS INTO A HOLE.
- (7) ~~Seepage Beyond Toe~~ THERE ARE WET AREAS BEYOND THE TOE

An investigation should be undertaken to determine why water disappears into a hole beyond the toe of the north embankment. The investigation should ascertain whether this condition has any adverse impact on the stability of the embankment.

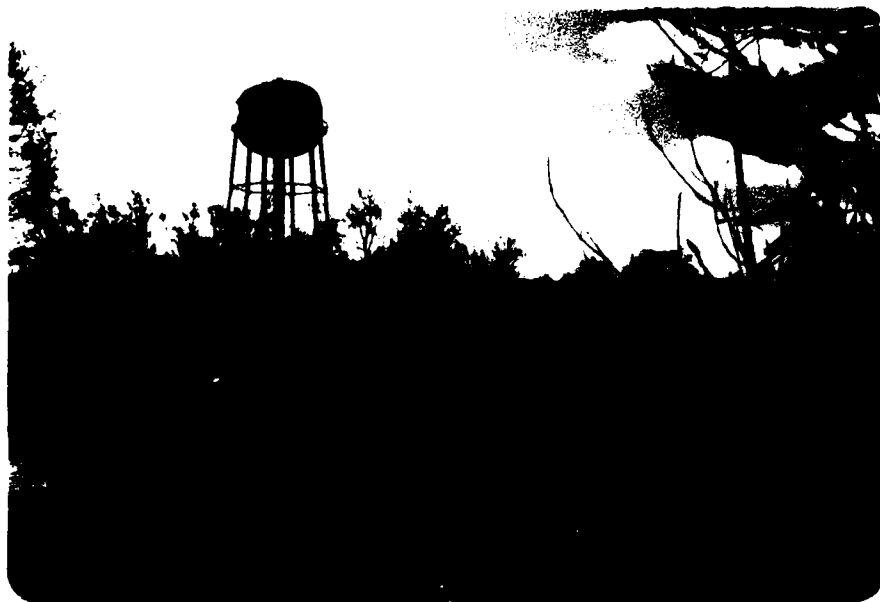
Southern End of Eastern Slope; Note Erosion Scars.

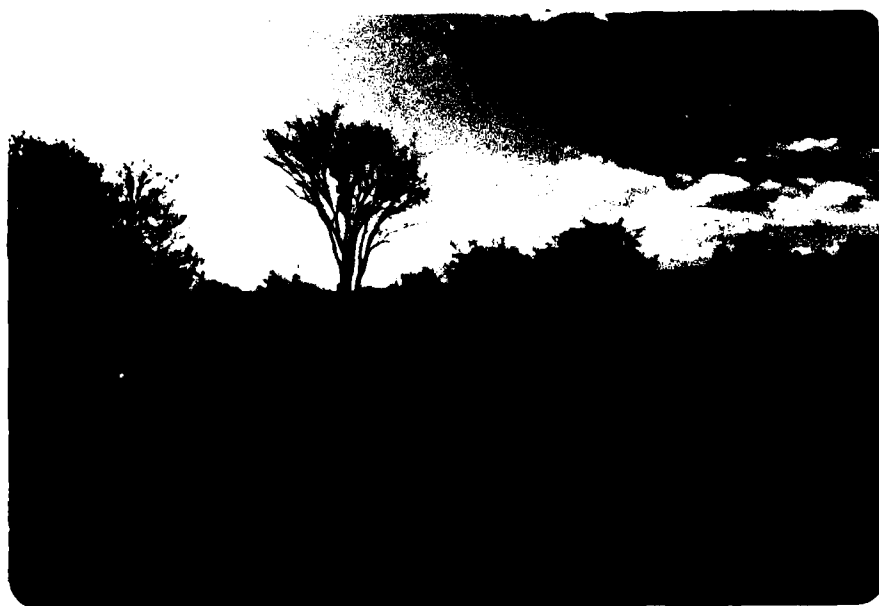
Northern End of Eastern Slope; Note Erosion Scars

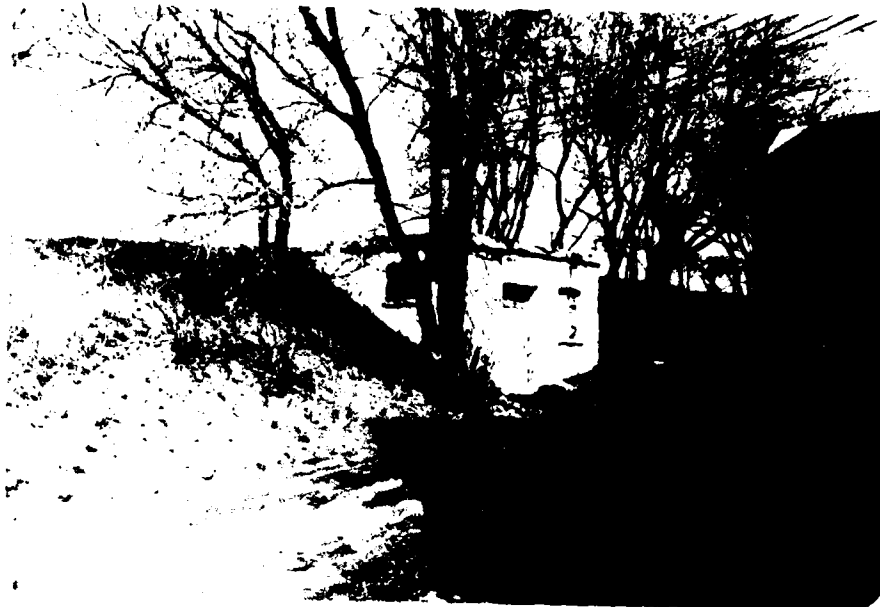
Gatehouse Cut into Eastern Outboard Slope; Note Trees  
on Slope
